Technical Bulletin

(1005326 Rev. A)

1003836 (RL-18)

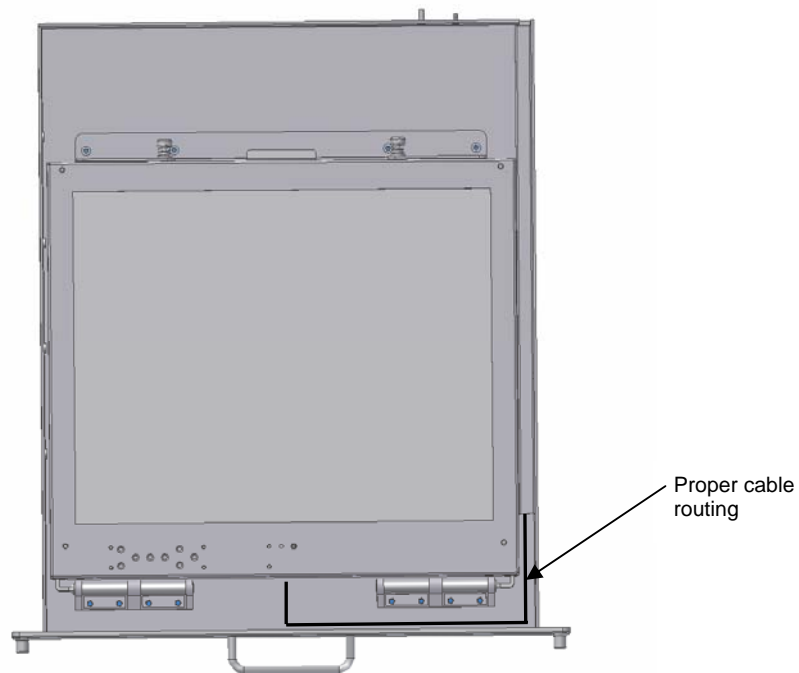
Figure 1

After lifting the monitor it is possible for the power & video cables to fold behind the monitor hinge. If the monitor is lowered with the cables folded behind the monitor hinge, the cables can be damaged by the monitor.

1. Before lowering the monitor ensure the cables stay as close as possible to the front and right walls of the case. Refer to figure 1 below for proper cable position.
